Commission of Inquiry into the Collapse of a Portion of the de la Concorde Overpass

October 3, 2006 - October 15, 2007

REPORT

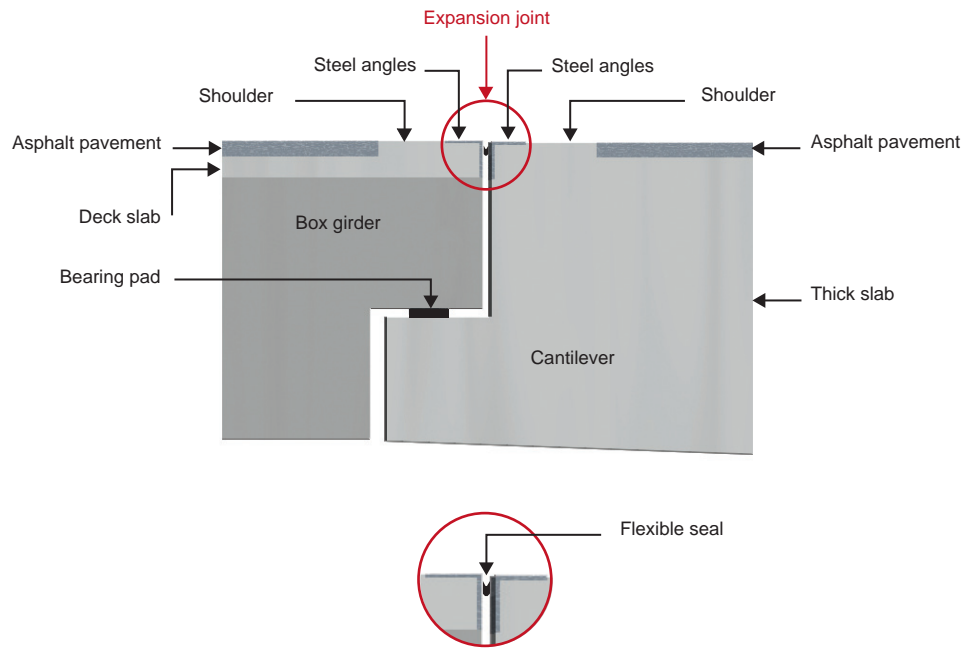
Figure S.1 Diagram Illustrating the Position of the Expansion Joint above the Seat

The box girders forming the central part of the deck rested on beam seats located at the ends of the cantilevers, directly under the expansion joints (Figure S.1). The end of the cantilever is a particularly complex load transfer area. The expansion joints are highly exposed parts which lose their ability to seal off water when damaged, contributing to the accumulation of water, road salts and debris on the chair bearing support. This vulnerability is even greater because the seats cannot be inspected and maintained without lifting the deck. To do so, traffic would have had to be interrupted on both Boulevard de la Concorde and Autoroute 19. The expansion joints and the ends of the cantilevers on this type of structure thereby constitute critical zones requiring special attention during inspections and maintenance work.

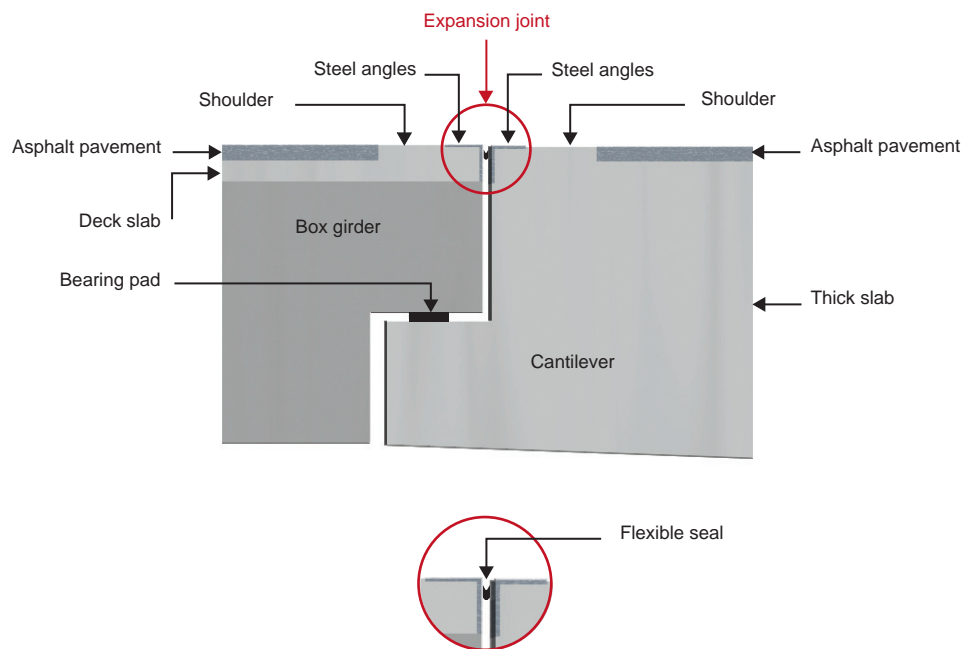
Figure 2.17 Diagram Illustrating the Position of the Expansion Joint Above the Chair Bearing Support

However, the box girders rest on chair bearing supports located at the end of the cantilevers, directly underneath the expansion joints (Figure 2.17). These joints are exposed parts, which lose their ability to seal off water if damaged, thus contributing to the accumulation of water, road salts and debris on the chair bearing support. The vulnerability is even greater because it is impossible to inspect and maintain these seats without lifting the deck. This operation would have necessitated the interruption of traffic both on Boulevard de la Concorde and on Autoroute 19. The expansion joints and the chair bearing supports are therefore a critical area on this type of bridge.

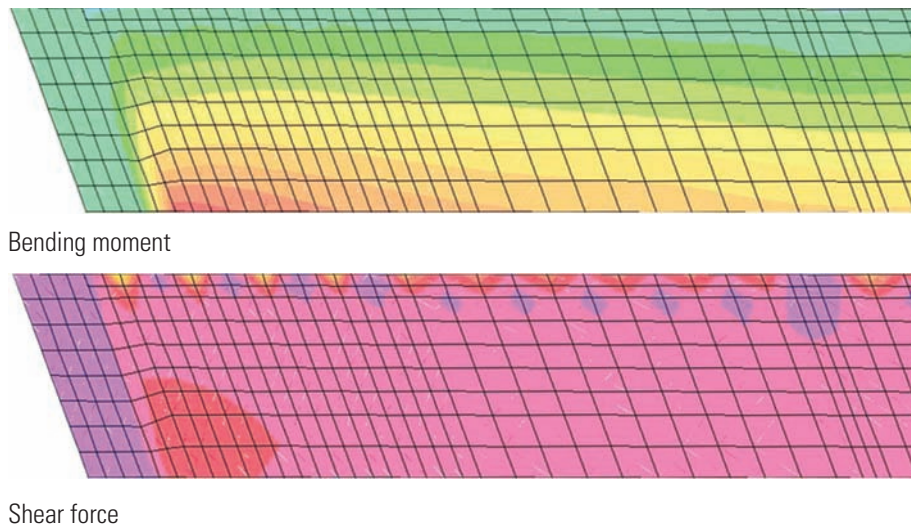
Figure 5.4 Distribution of the bending moment and the shear force in the cantilever of the de la Concorde overpass under dead load, showing the concentration of stresses due to the skew¹²

Mr. Dupaul states that the code allowed for a shear stress of up to 70 psi before any shear reinforcement was required.⁴³ The maximum shear stress calculated for the thick slab of the de la Concorde overpass abutments was 60 psi. However, the presence of a skew in the geometry of the abutment slabs creates stresses in the south corner of the east abutment and the north corner of the west abutment that exceed the average stresses calculated by Mr. Dupaul⁴⁴ (see Figure 2.1). In his calculations, he accounted for the effect of the skew by considering the total length of the cantilever measured along the axis of the bridge, and not perpendicular to the supporting wall. However, the finite element analysis tools that are commonly used today, but were not available in 1969, show that the forces are more concentrated than was indicated by Mr. Dupaul's calculations and that these calculated stresses exceed the stresses allowed by CSA-S6-1966.⁴⁵

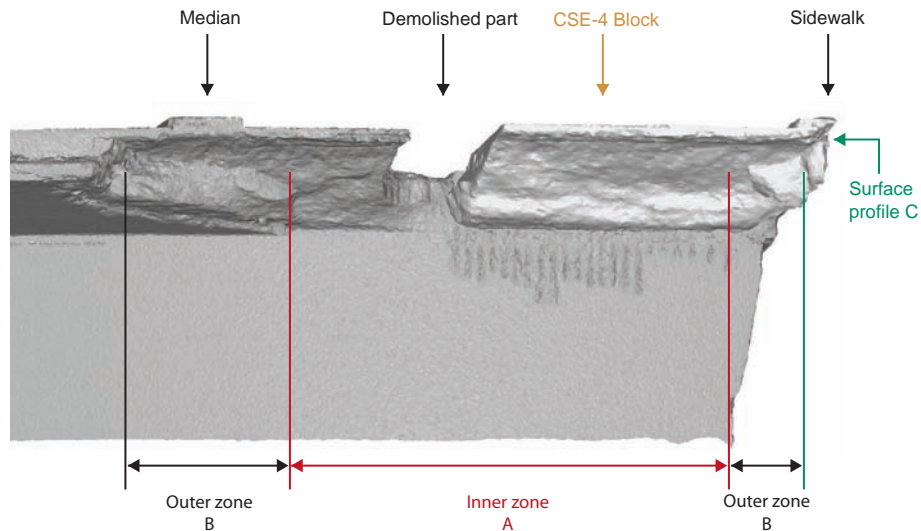
Figure 6.4 Three-dimensional reconstruction of the failure surface from survey report

Figure 6.4 represents the east abutment, seen from the front, generated by the three-dimensional reconstruction of a survey done with laser scanning by the Commission's experts. The viewpoint is similar to the viewpoint in Figure 6.2, except that the suspended lower blocks and the north superstructure have been removed. The gray sections were surveyed at the collapse site following removal of block CSE-4 (taken to the Belgrand Street site for measurement and analysis) and the partial dismantling necessary to its removal (a dismantled section, to the left of block CSE-4, is visible on Figure 6.5). The results of a similar survey were presented during the testimony of one of the experts, Professor Bruno Massicotte.⁵

Finally, on the exterior south face of the abutment, the profile of the failure surface is even more abrupt, and a small vertical slice of concrete remained attached to the abutment (as can also be seen on Figure 6.1 b). The failure surface, in this case, follows profile C.

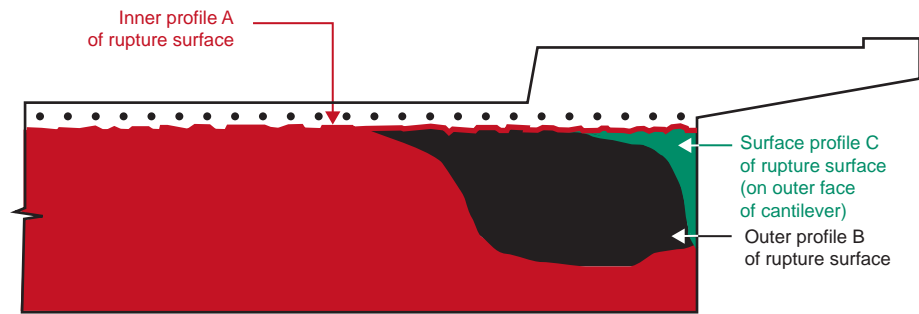
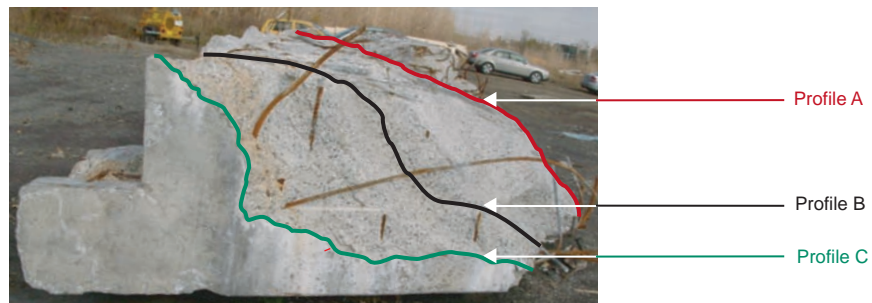
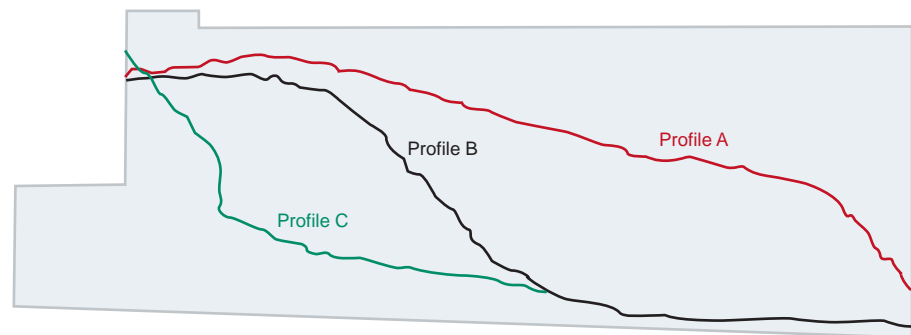
Figure 6.5 Schematic elevation of the cantilever of the east abutment, showing profiles of the failure surfaces.⁶

The three profiles of the three-dimensional failure surface are also schematically shown on the views in Figure 6.5. The picture of exhibit CSE3, detached from the overpass, included in Figure 6.5, clearly shows the contours of these three profiles.
